Commercial Vehicles and Vulnerable Road Users

**Jean-Louis Comeau
Brian Monk
Paul Boase
Dominique Charlebois
Peter Burns
Transport Canada**

Abstract

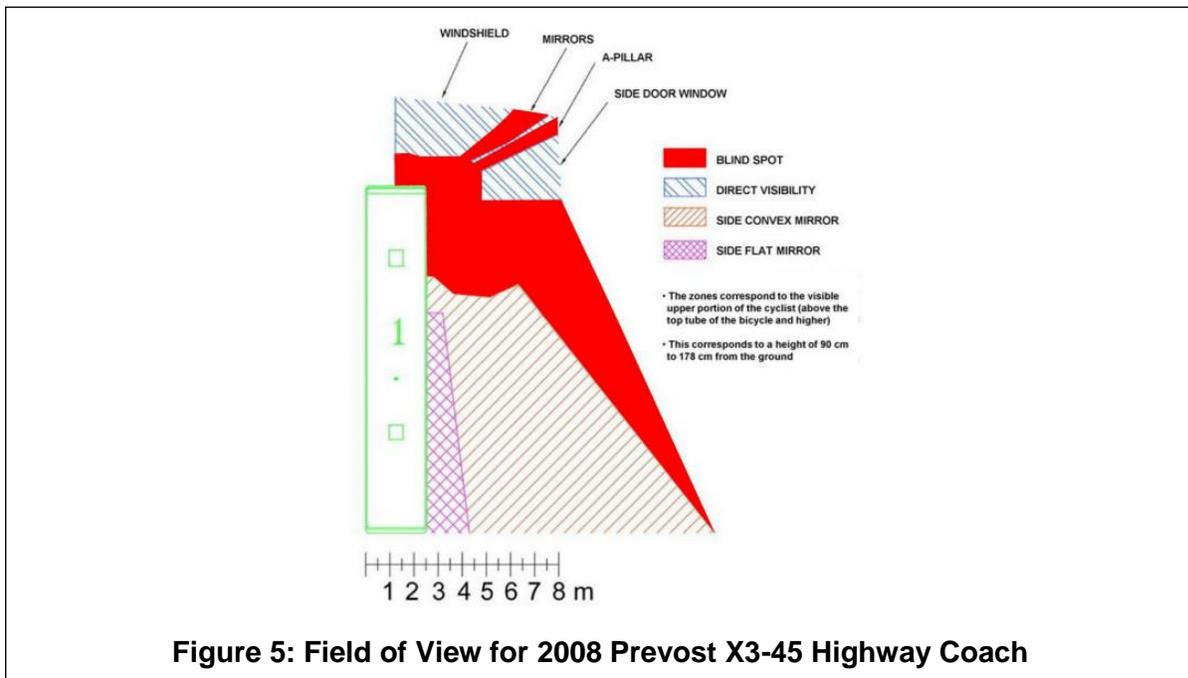
The bus was equipped with planar side-view mirrors with integrated smaller convex mirrors mounted to both front corners. The visibility zones, and the associated blind spots, for this configuration were mapped as shown in Figure 5.

The bus slowed to make the right turn onto the east/west road. At the same time, a teenage cyclist was travelling northbound along the sidewalk adjacent to the travel lane of the bus. The bus turned in front of the cyclist. The cyclist struck the side of the bus ahead of the rear axles, fell to the ground, was run over by the wheels on the two rear axles, and sustained fatal injuries.

The driver reported that he had not observed the cyclist on the sidewalk. It was noted that the bus had a side height from the ground, between the front and rear axles, of only 280 mm.

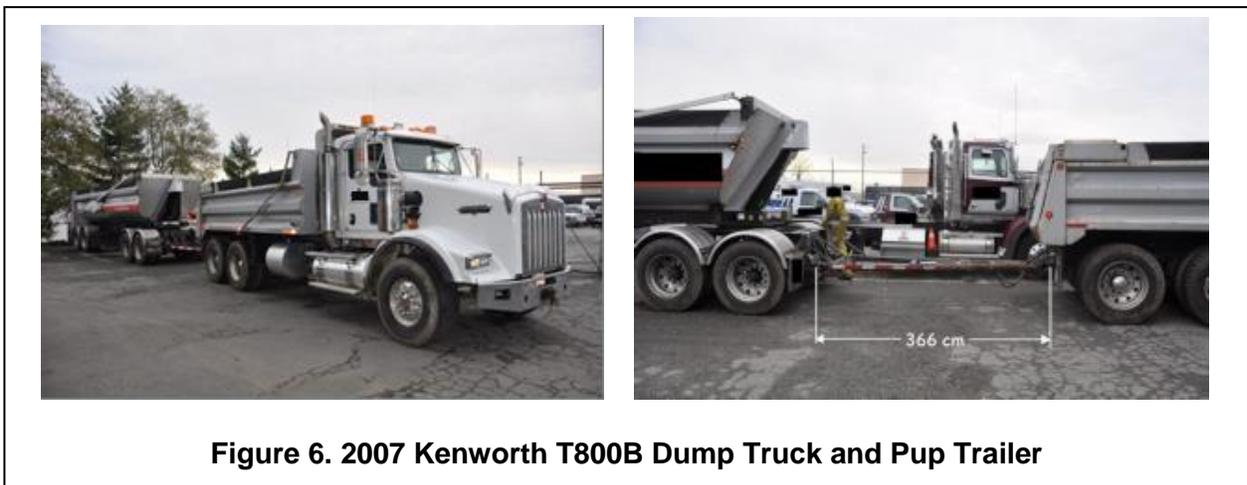
A 2007 Kenworth T800B dump truck, towing a Midland four-axle dump trailer, was eastbound along a designated truck route through an urban centre during daylight hours. A cyclist, using an eZee Liv electric bicycle, was also travelling eastbound along the right side of the road, ahead of the truck.

As the truck passed the cyclist, the rider, a 50-year-old male, moved to his left. He perhaps did not realize that the truck was towing the pup trailer by means of a 3.66 m long draw bar. The cyclist was struck by the trailer's first set of right-side wheels and was knocked to the ground. He was run over by the rear right-side wheels and sustained fatal chest and abdominal injuries.
